Concrete Supply Company - Lincolnton Plant

831 Madison St  
Lincolnton, NC 28092

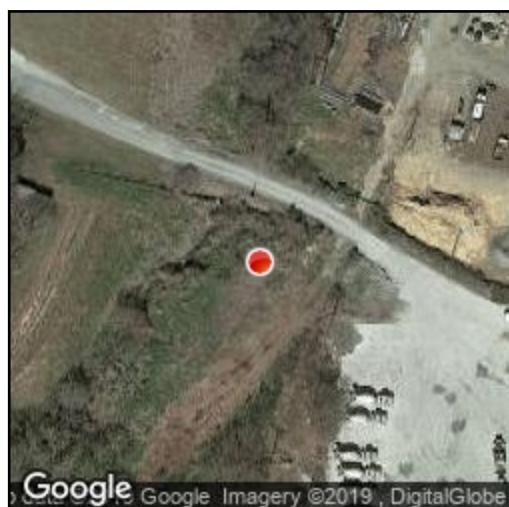
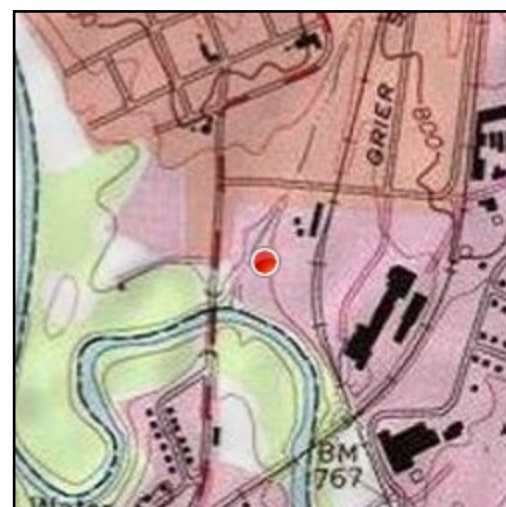
| Attributes | |
|---|--|
| File Name | DSCN1839.JPG |

| Attributes | |
|---|--|
| Description | Photograph of the ditch down gradient of Outfall 1 leading towards the creek. This area appeared to be accumulated silty material from the concrete process. Pooling water was observed in locations in the ditch in addition to the evidence of erosion features. |

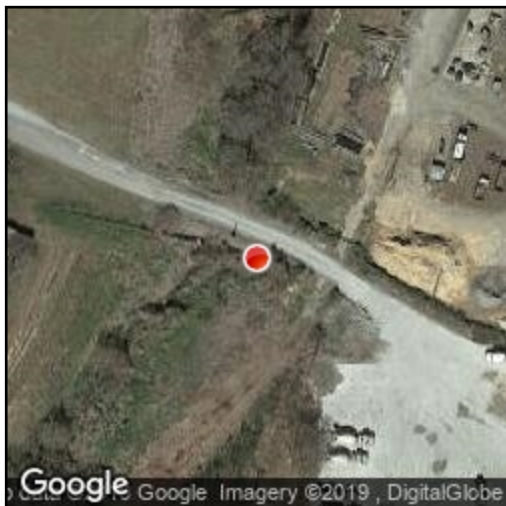
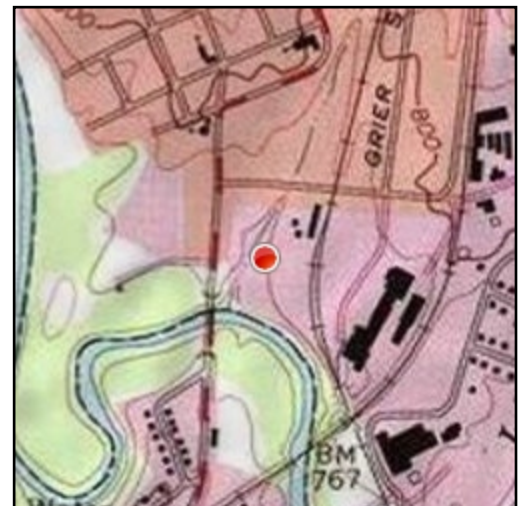
| File Name | DSCN1840.JPG |

| Description | Photograph of the ditch down gradient of Outfall 1 leading towards the creek. Pooling water was observed in locations in the ditch in addition to the evidence of erosion features. |

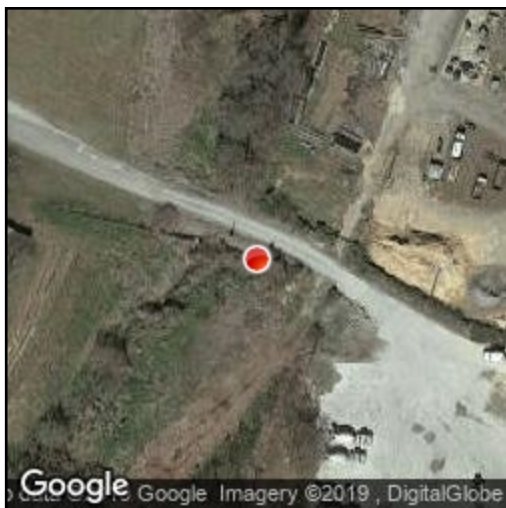
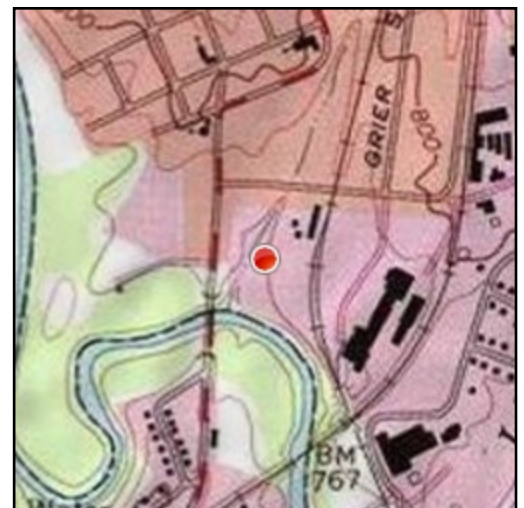
| Attributes | |
|---|---|
| File Name | DSCN1841.JPG |

| Attributes | |
|---|---|
| Description | Photograph of the ditch down gradient of Outfall 1 leading towards the creek. Pooling water was observed in locations in the ditch in addition to the evidence of erosion features. |

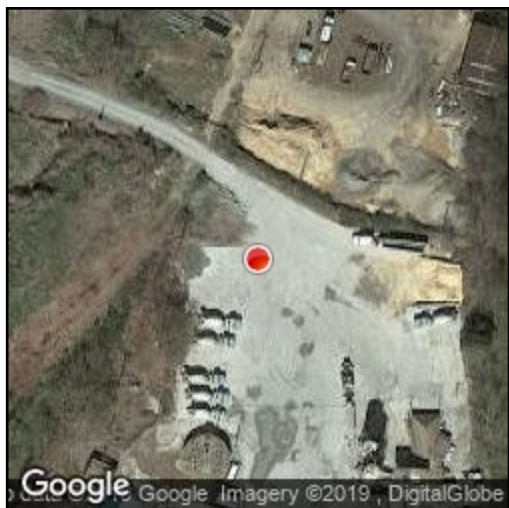
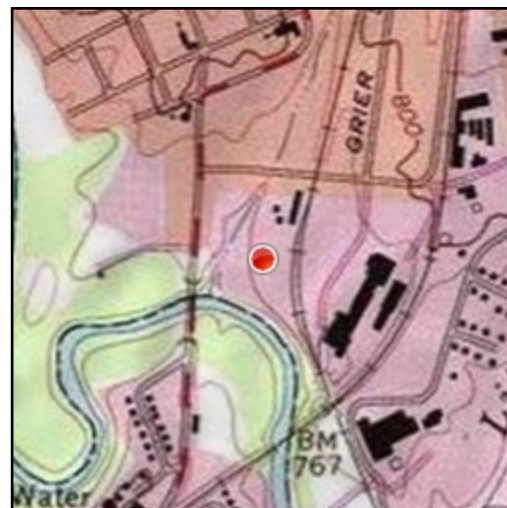
| File Name | DSCN1846.JPG |

| Description | Photograph of wastewater from truck washing operations observed during the site running towards the bermed area near the outfall. |

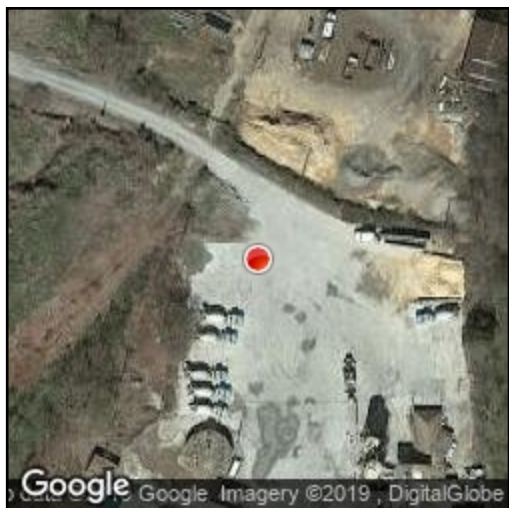
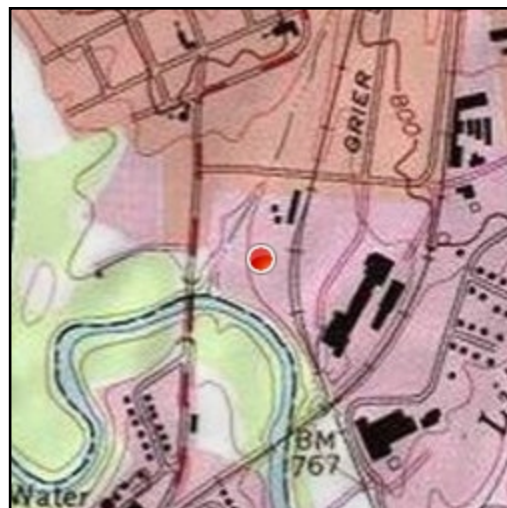
| Attributes | |
|---|---|
| File Name | DSCN1847.JPG |

| Attributes | |
|---|---|
| Description | Photograph of wastewater from truck washing operations observed during the site running towards the bermed area near the outfall. |

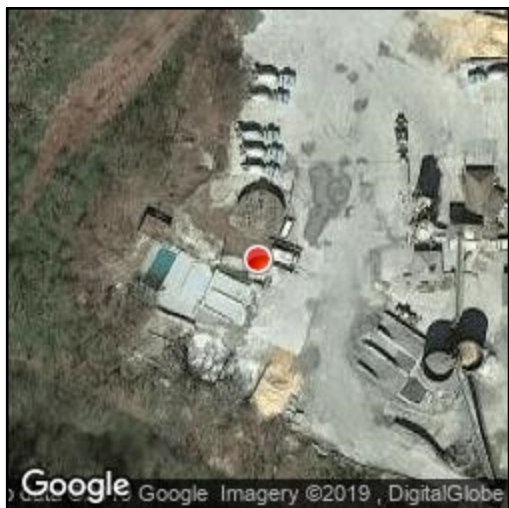
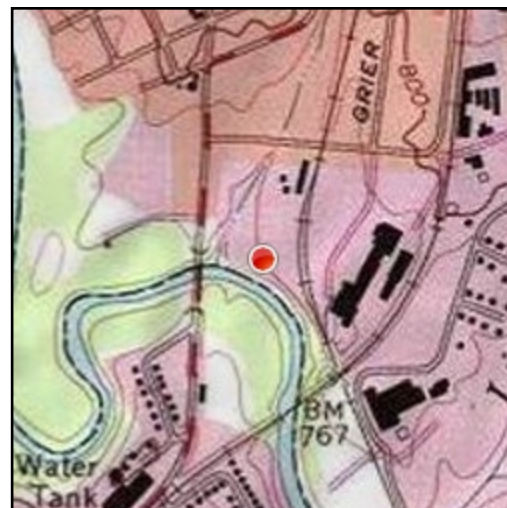
| Attributes | |
|---|--|
| File Name | DSCN1852.JPG |

| Attributes | |
|---|--|
| Description | Photograph of the diesel fuel tank and its secondary containment structure. A drainage valve was observed in the secondary containment structure. The valve was closed at the time of the inspection. Although a lock was not in place on the valve, the valve arm had been removed. |

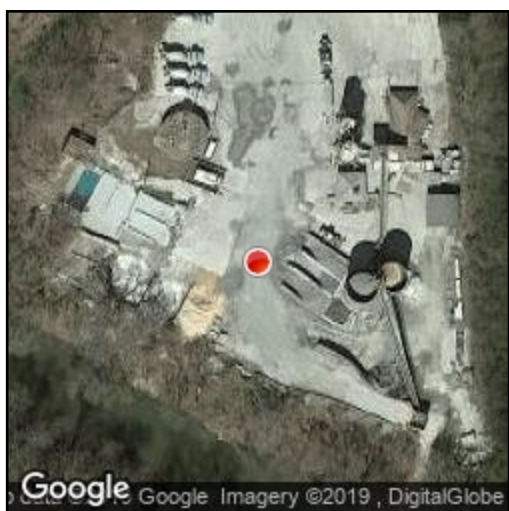
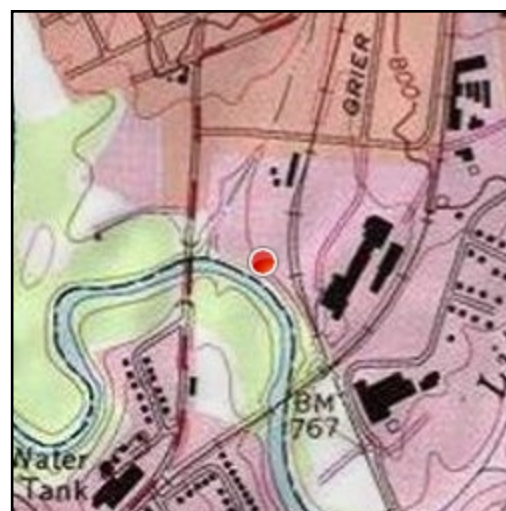
| File Name | DSCN1854.JPG |

| Description | Photograph of the material storage piles. Some sediment tracking was observed from the sand storage pile. A concrete waste storage area can be seen in the back of the photograph along the south side of the property. |

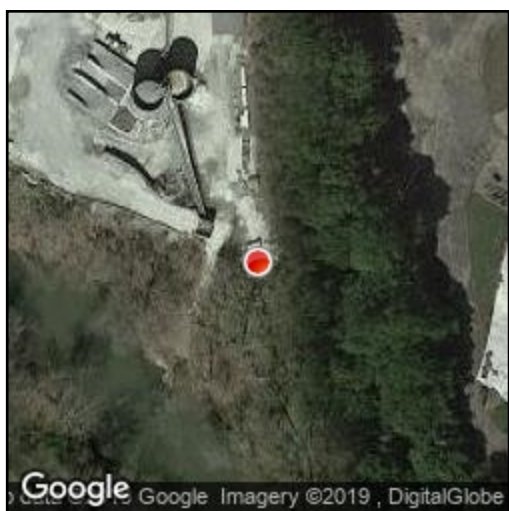
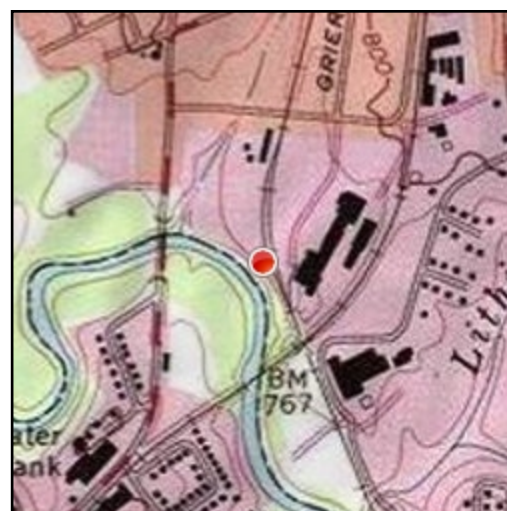
| File Name | DSCN1857.JPG |

| Description | Photograph of the area just down gradient of the removed outfall. The photo shows the concrete blocks used to block off the outfall. The block structure was observed with gaps between the blocks which would still allow for stormwater discharges. |

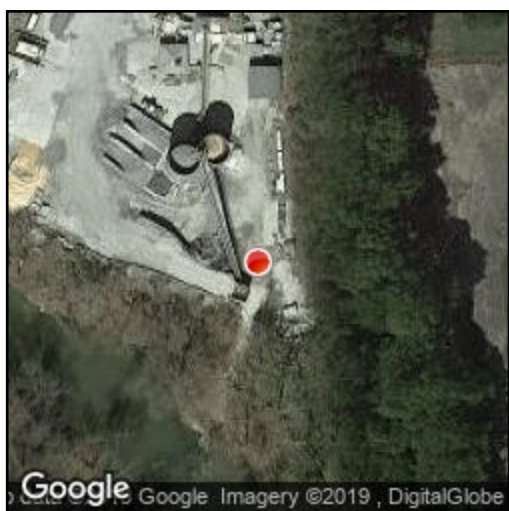
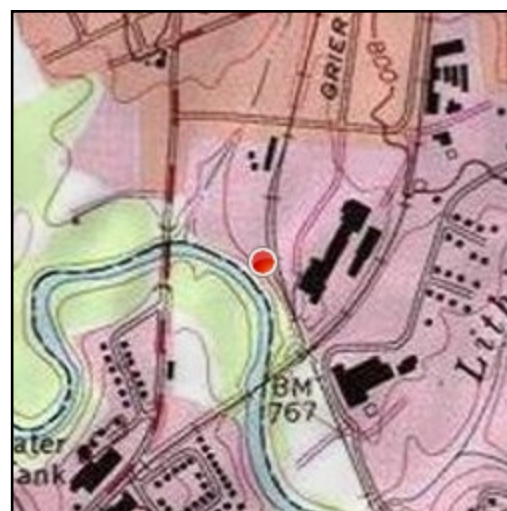
| File Name | DSCN1858.JPG |

| Description | Photograph of the loading hopper to the storage silos. The loading hopper was located near the crest of a hill leading to the stream. Sediment accumulation was observed along the ground in this area which drains towards the stream. |

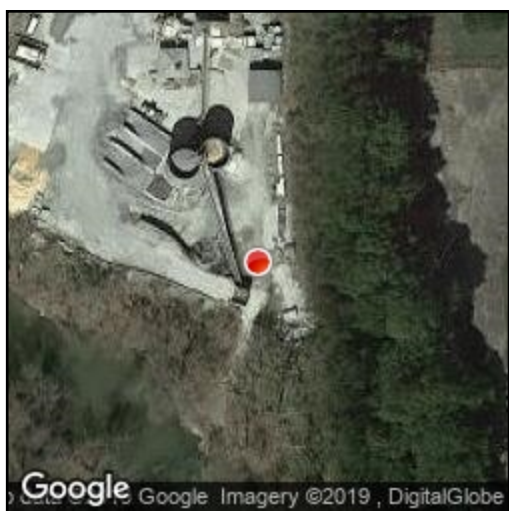
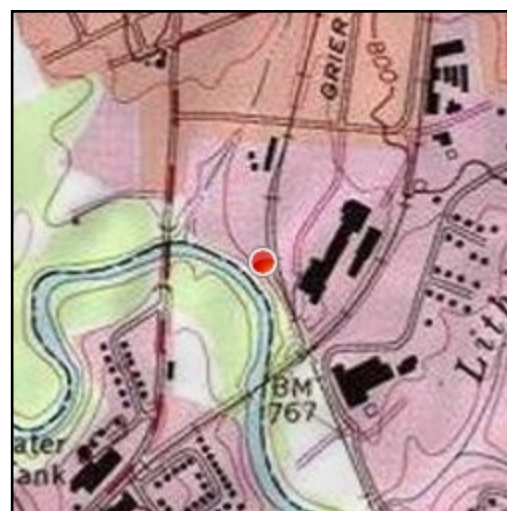
| File Name | DSCN1859.JPG |

| Description | Photograph of the loading conveyor to the storage silos. The loading hopper was located near the crest of a hill leading to the stream. Sediment accumulation was observed along the ground in this area which drains towards the stream. |

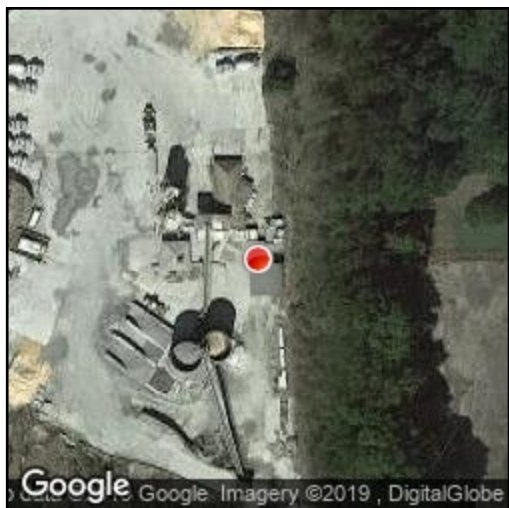
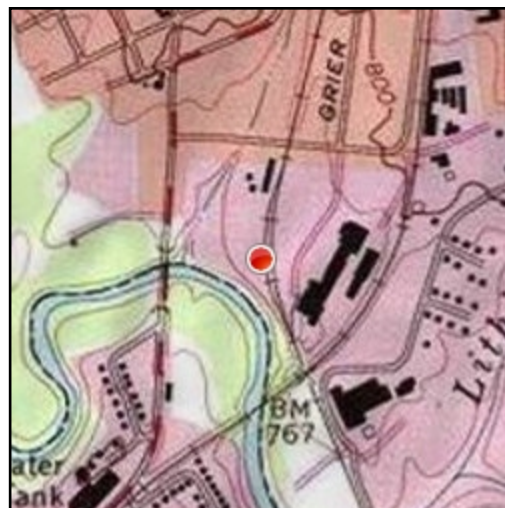
| File Name | DSCN1860.JPG |

| Description | Photograph of the covered area used for oil storage. Oil drums were observed on secondary containment structures and underneath cover. |

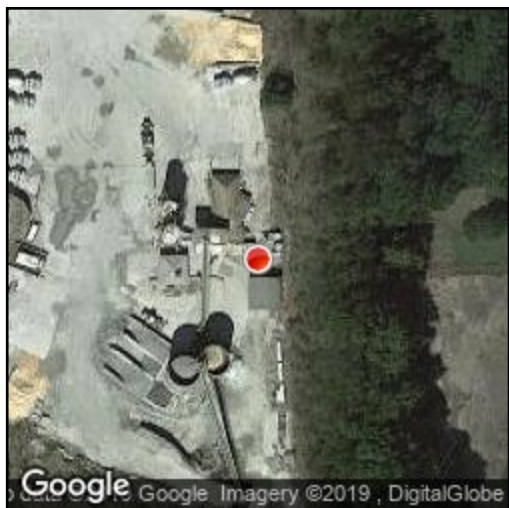
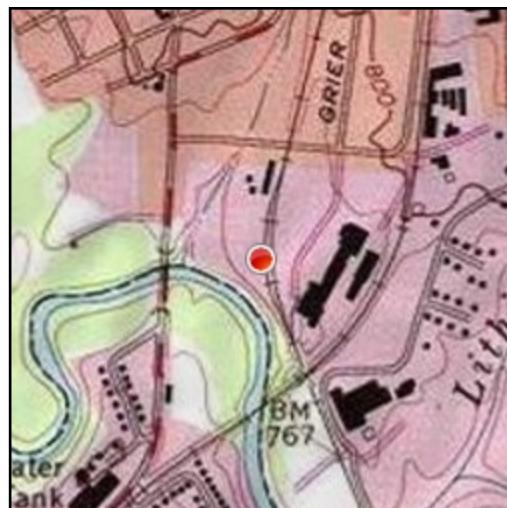
| File Name | DSCN1861.JPG |

| Description | Photograph of the outdoor chemical storage area and tanks. The tank area had a secondary containment structure with a release valve. The valve, which was observed with the valve handle removed, was observed closed during the inspection. |

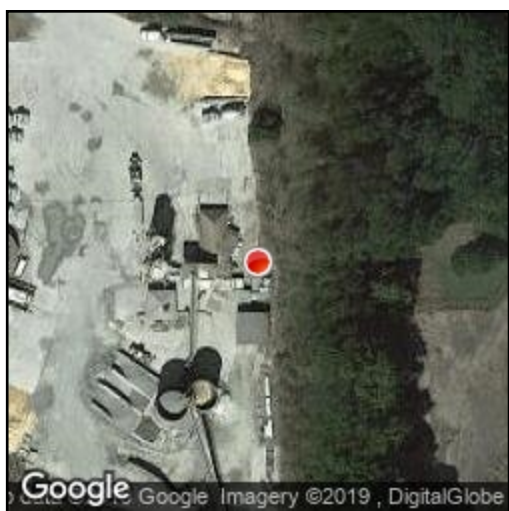
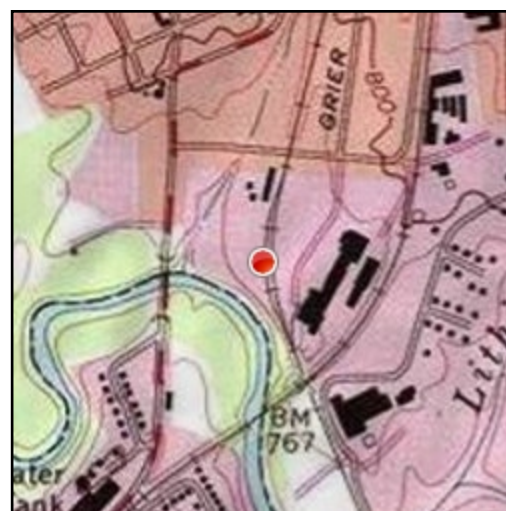
| Attributes | |
|---|--|
| File Name | DSCN1862.JPG |

| Attributes | |
|---|--|
| Description | Photograph of the outdoor chemical storage area and tanks. The tank area had a secondary containment structure with a release valve. The valve, which was observed with the valve handle removed, was observed closed during the inspection. |
